UPDATE

August 2, 1993

NIOSH Warns Workers About Explosive Respirator Cylinders

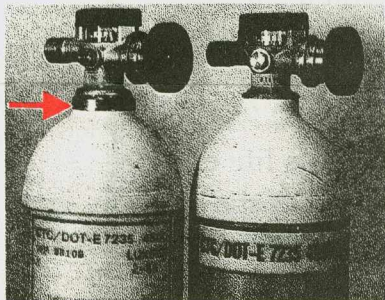
Cylinder on left fitted with steel reinforcing ring.

The Institute has received several reports of these cylinders leaking or exploding, as a result of metal fatigue in the neck area. Recognizing the hazard, NIOSH and the U.S. Department of Transportation (DOT) in October 1985, began requiring that these cylinders be retrofitted with a steel reinforcing ring. The cylinder causing this death was not retrofitted and was in service beyond its maximum 15-year service life. NIOSH urges all workers using these cylinders to make sure that they are both retrofitted and within the approved service life.

- Immediately inspect all compressed gas cylinders in your possession or your work area.
- Immediately remove from service any DOT-E 7235 4500 PSI cylinder that does not have a steel reinforcing ring on the neck area.
- Immediately remove from service any DOT-E 7235 4500 PSI cylinder that has exceeded the 15-year service life. This life can be determined by the earliest date stamped on the neck of the cylinder. Pressure (i.e. hydrostatic) retesting cannot extend service life beyond 15 years.
- Identify the last hydrostatic retest date stamped on the neck and remove the cylinder from service if the date is more than 3 years old.
- Treat all compressed gas cylinders with caution and follow the manufacturer's recommended safe work practices when refilling (i.e. charging), handling, and disposing of any charged cylinders.
